# Technical Due Diligence for Engineering Services

**Example Park, Sample Way, Sampletown**

Prepared by Example Consulting Ltd  
for Example Property Holdings Ltd

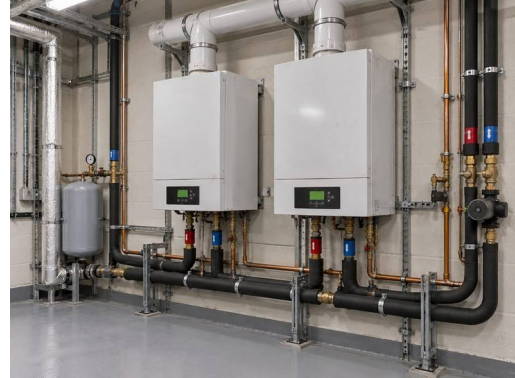
Two wall hung gas condensing boilers in the main plant room, installed in 2020 (Photo 2), serve low temperature hot water to perimeter panel radiators (Photo 12), the heating coil in the air handling unit and the calorifier. Both boilers were running at the time of our inspection, with minor casing scuffs and some tarnishing of the exposed pipework, consistent with their age.

Photo 2: Gas condensing boilers, main plant room

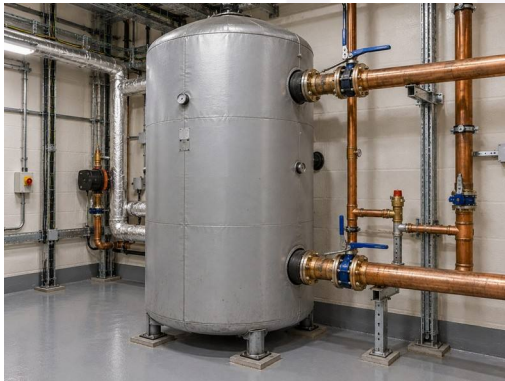
Hot water for the main block is from a calorifier heated by the boilers, with a pumped return (Photo 3). The office wing kitchenettes have local electric storage water heaters (Photo 18). One shows limescale at a pipe joint below the heater, which should be remade at the next service. The electric water heaters have a shorter expected life than the central plant and their replacement should be planned within five years.

Photo 3: Calorifier, main plant room

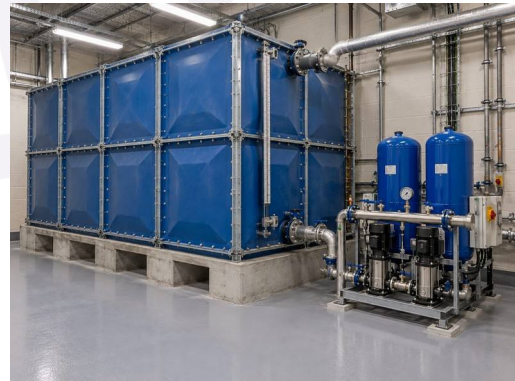
The incoming mains water supply enters the main plant room and fills a sectional GRP cold water storage tank, from which a duplex booster set serves the building (Photo 4). Both are in good condition.

Photo 4: Cold water storage tank and booster set

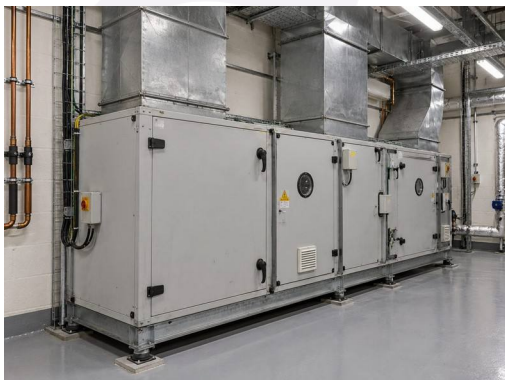
The main block is ventilated by an air handling unit with heat recovery in the main plant room (Photo 5), supplying and extracting through ductwork in the risers. It is in fair condition, with scuffs to the access panels and light dust at the duct seams. A mid life overhaul of the fans, drives and controls is usually needed at around ten years and should be planned within five years. Filter change records were not on site and should be requested.

Photo 5: Air handling unit, main plant room

| Ref | Element | Recommendation | Rating | Timescale | Budget | Source |
|---|---|---|---|---|---|---|
| R14 | Ventilation | Mid life overhaul of the air handling unit fans, drives and controls. | 2 | Years 2 to 5 | £14,000 | Photo 5; rec 00:15:40 |

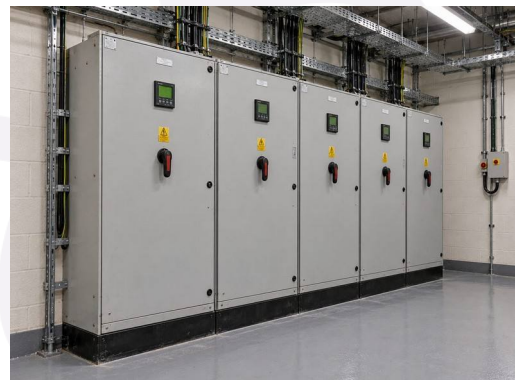
The property is supplied from a dedicated substation owned by the distribution network operator. The main LV switchgear, a five panel assembly with metered outgoing ways, is in the electrical service room (Photo 6). It feeds distribution boards on each floor, which have up to date circuit charts (Photo 7). The installation is in good condition.

Photo 6: Main LV switchgear, electrical service room

should be carried out now. A thermographic survey of the switchgear under load within a year is also recommended as good practice.

| Ref | Element | Recommendation | Rating | Timescale | Budget | Source |
|---|---|---|---|---|---|---|
| R10 | Electrical | Thermographic survey of the main LV switchgear under load. | 1 | Year 1 | £1,800 | Photo 6; rec 00:30:05 |

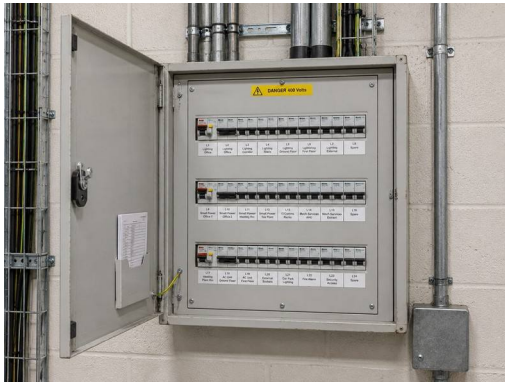
Photo 7: Typical floor distribution board

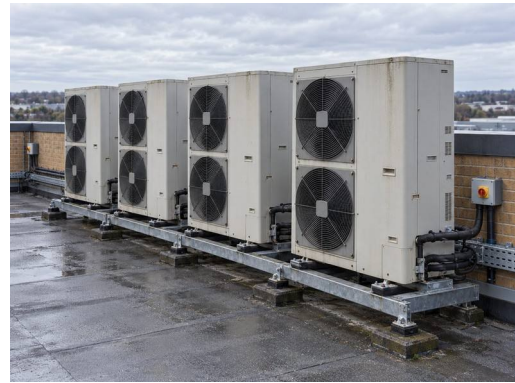
The main block office floors are served by VRF heat recovery systems installed in 2020, with four condensing units on the roof plant platform (Photo 8) and four way ceiling cassettes (Photo 10). The systems use R410A refrigerant.

The units are in good condition, with light dust on the coil fins and slight fading of the casings. We do not expect replacement within five years. R410A is a high global warming potential refrigerant; under the GB F-gas rules its supply is being phased down and it is becoming more expensive to obtain for servicing, which should be borne in mind when the systems are replaced.

No air conditioning inspection report was provided. Systems of this size must be inspected at intervals of not more than five years, so an inspection is now due and should be arranged. The F-gas register and leak test records should also be requested.

Photo 8: VRF condensing units, roof plant platform

| Ref | Element | Recommendation | Rating | Timescale | Budget | Source |
|---|---|---|---|---|---|---|
| R5 | Comfort cooling | Arrange the air conditioning inspection; no report was provided. | 2 | Immediate | £2,200 | Photo 8; rec 00:18:30 |

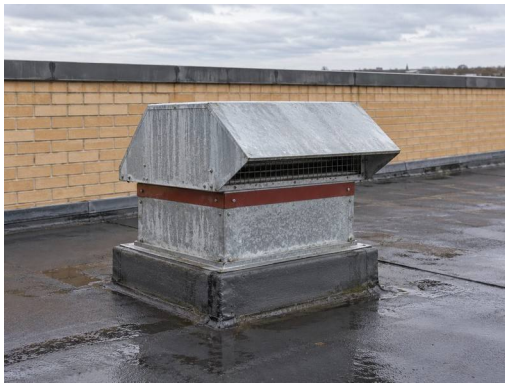
WC extract is by fans discharging through galvanised cowls on the main roof (Photo 9). Water was standing on the roof membrane around the cowl upstand at the time of our visit. This may follow recent rain, but the falls and outlets around the upstand should be checked by the building surveyor within a year.

Photo 9: WC extract cowl, main roof

| Ref | Element | Recommendation | Rating | Timescale | Budget | Source |
|---|---|---|---|---|---|---|
| R9 | Ventilation | Building surveyor to check the roof falls around the extract cowl upstand. | 2 | Year 1 | £800 | Photo 9; rec 00:21:10 |

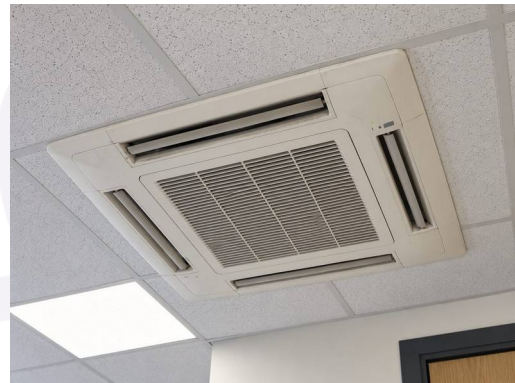
Photo 10: VRF ceiling cassette, typical office floor

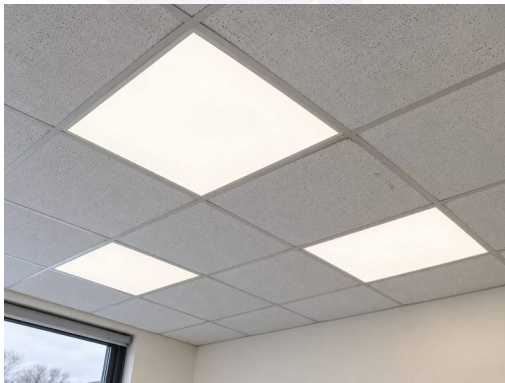
Lighting is LED throughout: recessed panels on the office floors (Photo 11), high bay pendants in the service wing (Photo 22) and battens in the service corridors (Photo 23), where the diffusers are slightly yellowed at the ends and can be replaced within five years. Otherwise the lighting is in good condition and should not need replacing within five years.

Photo 11: LED panels, typical office floor

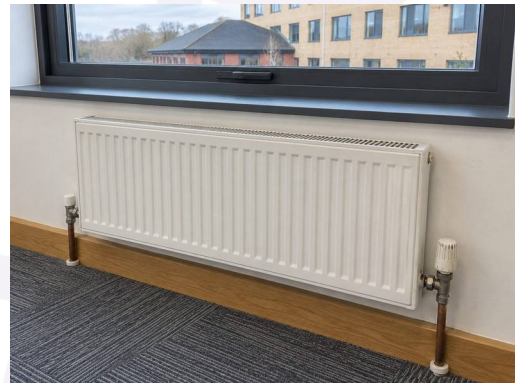
Photo 12: Perimeter panel radiator, office floor

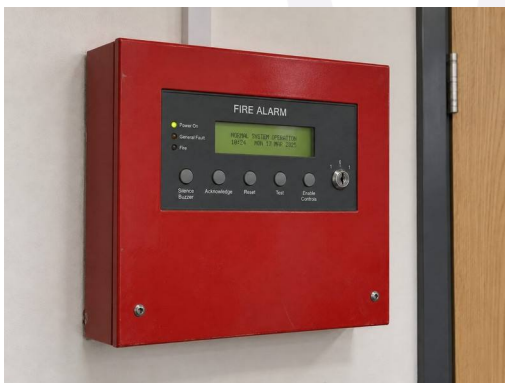
The building has an addressable fire detection and alarm system, which appears to be a category L2 system, with the panel at the ground floor entrance (Photo 13). The panel showed normal operation at the time of our visit. The service label shows the last service eight months ago; BS 5839-1 recommends servicing at intervals of not more than six months, so a service is overdue and should be arranged now.

The detectors were installed in 2020. Manufacturers commonly recommend replacing smoke detectors at around ten years, so their replacement should be planned within five years. The panel and cabling are suitable for retention, subject to routine servicing.

Photo 13: Fire alarm panel, ground floor entrance

| Ref | Element | Recommendation | Rating | Timescale | Budget | Source |
|---|---|---|---|---|---|---|
| R2 | Fire protection | Arrange the fire alarm service, now overdue, and record it in the logbook. | 3 | Immediate | £650 | Photo 13; rec 00:40:05 |

| Ref | Element | Recommendation | Rating | Timescale | Budget | Source |
|---|---|---|---|---|---|---|
| R11 | Fire protection | Replace the smoke detectors at around ten years old. | 2 | Years 2 to 5 | £24,000 | Photo 13; rec 00:40:50 |

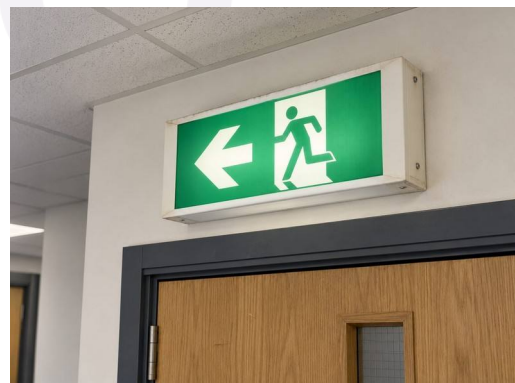
Emergency lighting is by self contained fittings and exit signs (Photo 14). The monthly tests are logged, but there is no record of the annual full duration test for 2026. Batteries in self contained fittings commonly last around four to five years, so at six years they are likely to fail a full duration test. Battery replacement and a full test should be carried out within a year.

Photo 14: Exit sign, ground floor corridor

| Ref | Element | Recommendation | Rating | Timescale | Budget | Source |
|---|---|---|---|---|---|---|
| R6 | Emergency lighting | Replace the batteries in the self contained fittings and carry out a full duration test. | 2 | Year 1 | £7,500 | Photo 14; rec 00:37:15 |

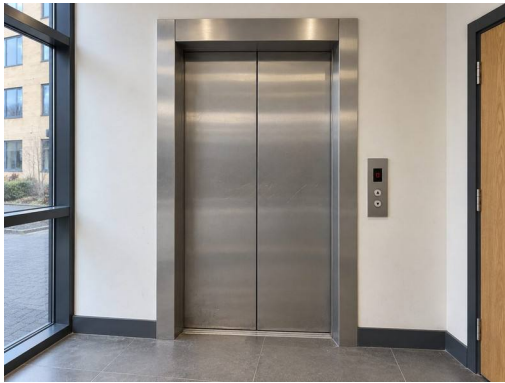
A lift specialist survey was not part of our instruction. The main block has two 13 person passenger lifts serving all floors, installed in 2020 (Photo 15). They were operating normally and are in good condition, with fine scratches at hand height. A thorough examination report under LOLER dated June 2026 was seen, with no defects noted. No works are expected within five years.

Photo 15: Passenger lift, ground floor lobby

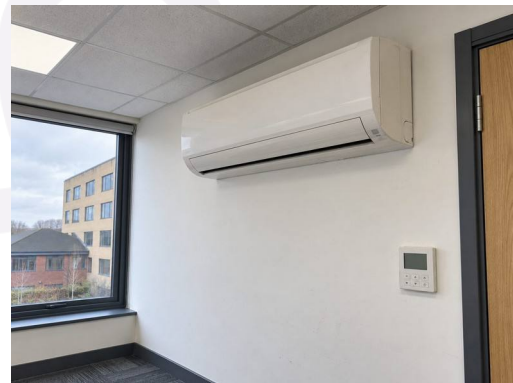
The office wing meeting room has a wall mounted split unit (Photo 17), in good condition.

Photo 17: Split air conditioning unit, meeting room

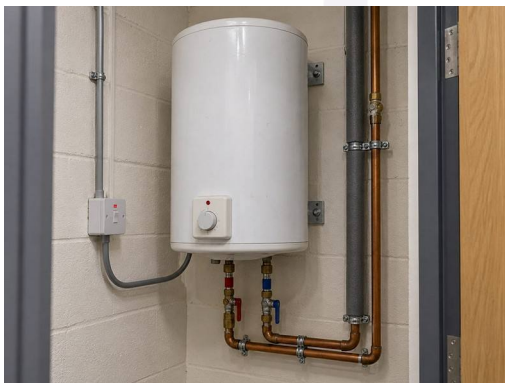
Photo 18: Electric water heater, kitchenette

| Ref | Element | Recommendation | Rating | Timescale | Budget | Source |
|---|---|---|---|---|---|---|
| R8 | Domestic water | Remake the pipe joint showing limescale below the kitchenette water heater. | 2 | Year 1 | £250 | Photo 18; rec 00:47:55 |

| Ref | Element | Recommendation | Rating | Timescale | Budget | Source |
|---|---|---|---|---|---|---|
| R13 | Domestic water | Replace the office wing electric water heaters at the end of their life. | 2 | Years 2 to 5 | £4,800 | Photo 18; rec 00:48:20 |

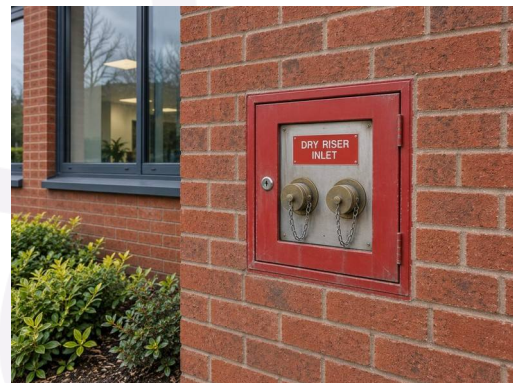
A dry riser serves the main block, with the inlet on the front elevation of the office wing (Photo 19). The inlet cabinet paint is faded at the edges, but the couplings and caps are intact. The latest test certificate was not available and should be requested.

Photo 19: Dry riser inlet, front elevation

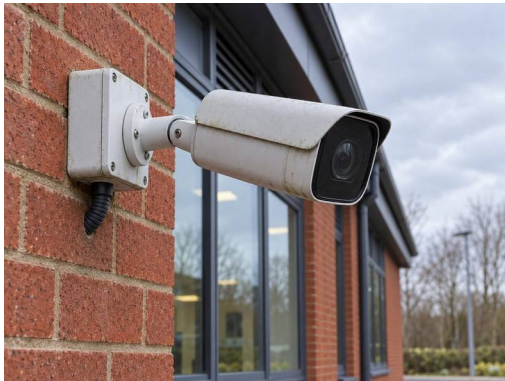
External CCTV cameras cover the forecourt and service yard (Photo 20) and are in good condition. They reach about ten years old in 2030 and their replacement should be planned within five years. Access control on the entrances and lift lobbies is specific to the current occupier and has been excluded from the costs.

Photo 20: External CCTV camera

| Ref | Element | Recommendation | Rating | Timescale | Budget | Source |
|---|---|---|---|---|---|---|
| R15 | Security | Replace the external CCTV cameras and recorder at around ten years old. | 2 | Years 2 to 5 | £18,000 | Photo 20; rec 00:50:10 |

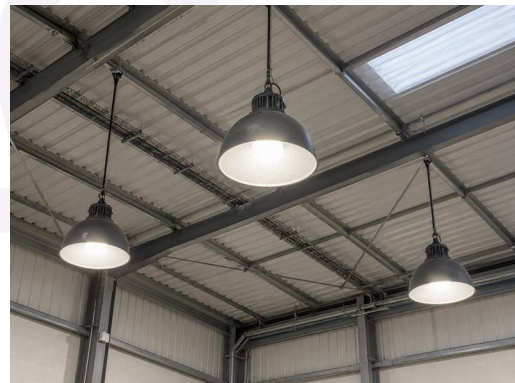
Photo 22: LED high bay lighting

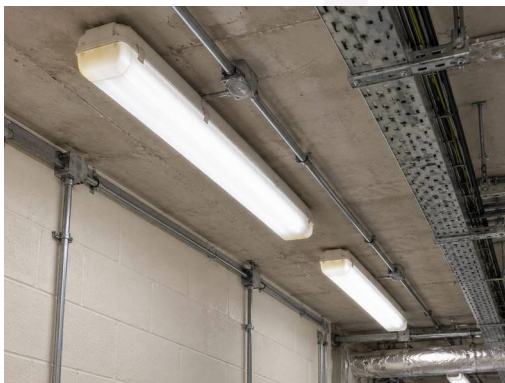
Photo 23: LED batten fittings, service corridor

| Ref | Element | Recommendation | Rating | Timescale | Budget | Source |
|---|---|---|---|---|---|---|
| R17 | Lighting | Replace the yellowed batten diffusers in the service corridors. | 1 | Years 2 to 5 | £1,200 | Photo 23; rec 00:54:05 |

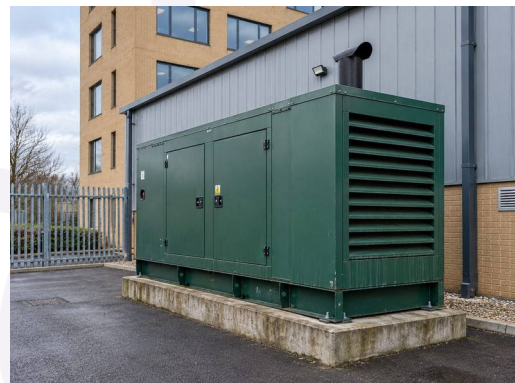
A standby diesel generator in an acoustic enclosure in the rear service yard supports the life safety systems (Photo 24). It is in fair condition, with some fading of the enclosure coating and rain streaks below the louvres. No load bank test record for the last twelve months was available; a test and service should be carried out within a year.

Photo 24: Standby generator, rear service yard

| Ref | Element | Recommendation | Rating | Timescale | Budget | Source |
|---|---|---|---|---|---|---|
| R7 | Electrical | Load bank test and service of the standby generator. | 2 | Year 1 | £1,200 | Photo 24; rec 00:52:40 |
