# Technical Due Diligence for Engineering Services

**Example Park, Sample Way, Sampletown**

Prepared by Example Consulting Ltd  
for Example Property Holdings Ltd

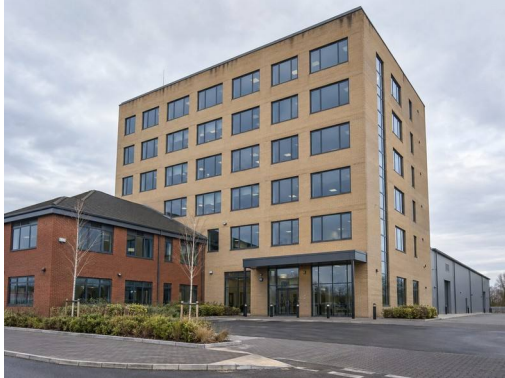
Photo 1: Main office block and office wing, front

Example Park is a single connected property completed in 2020. It comprises a six storey buff brick main office block (Photo 1), a two storey red brick office wing at the front (Photo 16) and a single storey metal clad service wing at the rear with two loading doors (Photo 21). The gross internal area is about 8,000 m<sup>2</sup>: 6,000 m<sup>2</sup> in the main block, 900 m<sup>2</sup> in the office wing and 1,100 m<sup>2</sup> in the service wing.
